PRATT AND WHITNEY AIRCRAFT GROUP WEST PALM BEACH FL 6--ETC F/G 21/5
SHOCK WAVE THERMOMECHANICAL PROCESSING OF GAS TURBINE DISKS. (U)

PWA-FR-13925

4. TITLE (and Subtitle) SHOCK WAVE THERMOMECHANICAL PROCESSING OF GAS TURBINE DISKS.		5. TYPE OF REPORT & PERIOD COVERED Final Report 1 Aug 1979 through 8 Nov 1980

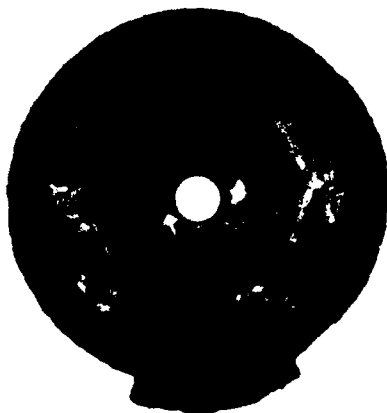
Figure 12. F100B Subscale Disk No. 1 — Schedule I, Shocked at 17,500 MPa (2540 ksi 175 kbar)

(a) Impact Surface

(b) Opposite Impact Surface

(c) Opposite Impact Surface

F100B Disks No. 1 (Schedule I) and No. 6 (Schedule II) sustained the most severe damage. These disks were the only F100B-type disks shocked. Shocking at the maximum pressure investigated of 17,500 MPa (2540 ksi/175 kbar) destroyed the entire rim section of both disks as shown in Figures 12 and 13. In addition, cracks were observed in both disks, propagating from the potting holes at the impact and opposite surfaces. The 15,000 MPa (2175 ksi/150 kbar) shocked Disk No. 2 (Schedule I) displayed circumferential mid-rim and radial potting hole cracks opposite the impact surface, as shown in Figure 14, and a small radial potting hole crack at the impact surface. The 15,000 MPa shocked Disk No. 7 (Schedule II) exhibited partial rim removal, as shown in Figure 15. Disk No. 9 showed fractures similar to Disk No. 2, as shown in Figure 16. The 12,500 MPa (1810 ksi/125 kbar) shocked Disk No. 3 (Schedule I) showed a circumferential mid-rim crack opposite the impact surface, as noted in Figure 17.

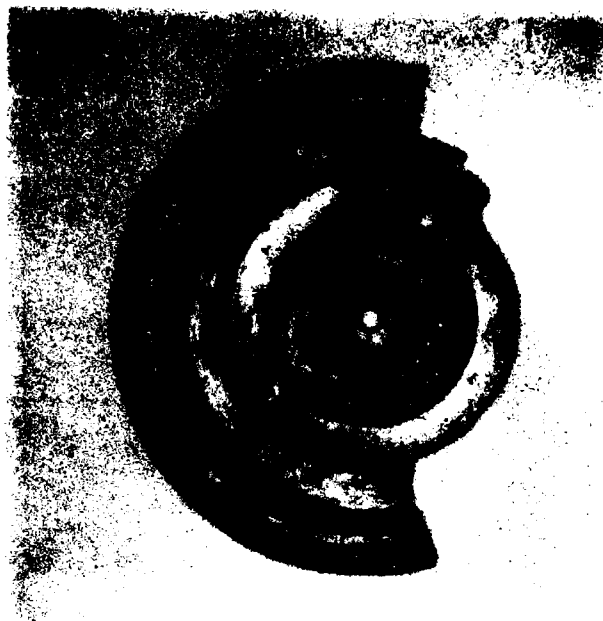
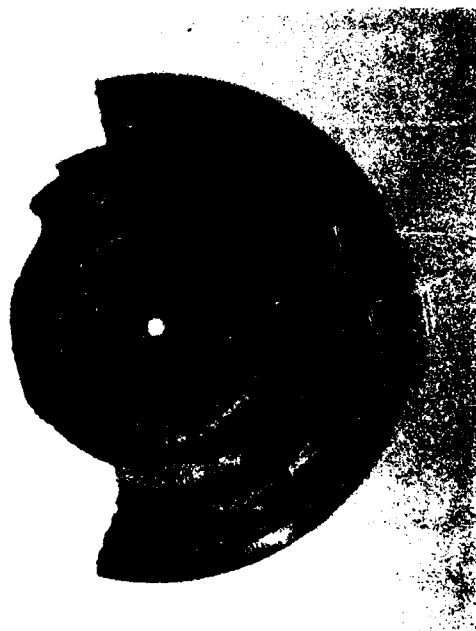
Figure 15. TF30 Subscale Disk No. 7 — Schedule II, Shocked at 15,000 MPa (2175 ksi 150 kbar)

Mag: 0.5X (a) Impact Surface

Mag: 0.5X (b) Opposite Impact Surface
